# EMBANKMENT CRITERIA AND PERFORMANCE REPORT

**MARCH 1983**

MISSOURI RIVER
FORT RANDALL DAM-LAKE FRANCIS CASE

20. ABSTRACT (Continue on reverse state if necessary and identify by block number)
Foundation features, earthfill design, construction, instrumentation, and
performance history of the Fort Randall Dam embankment are summarized. The 165foot high embankment was constructed in six earthwork stages, from 1947 through
1955, and is composed of approx. 50,000,000 cubic yards of rolled earthfill and
chalkfill materials. It is founded on pervious alluvial soils in the valley
and loess and glacial till in the abutments. Relief wells aid in controlling
seepage. Instrumentation includes piezometers, settlement gages, crest and
slope movement markers, tiltmeters, and strong motion accelerographs.

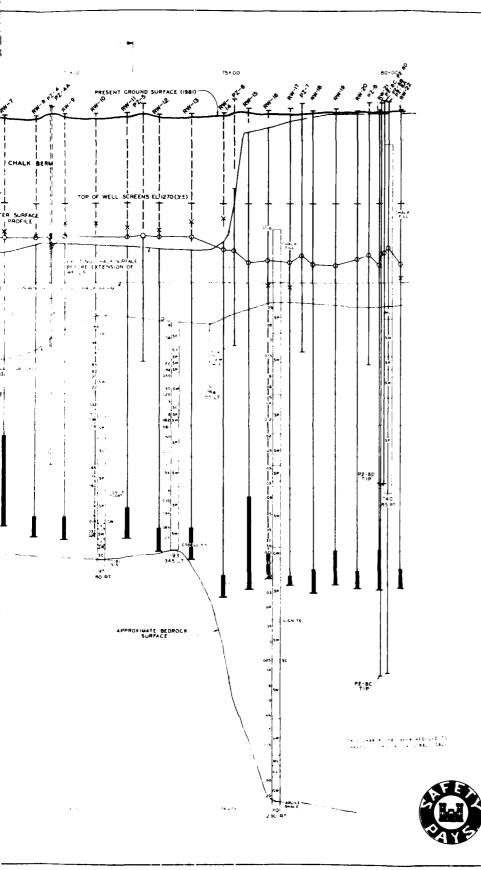
PRESSURE RELIEF WELL LOCATIONS						
	1	145151	CLC LOCALIST	TOP		
RELIEF WELL NO.	STATION	RANGE	BOTTOM ELEVATION	RISER ELEVATION		
ì	61+80	5800	1202.46	1298, 48		
2	62+80	5800	1177,70	1296,70		
. 3	63+80	5800	1171, 81	1296, 81		
4	64+B0	5800	1169, 27	1297.87		
5	65+80	5800	1571, 91	1298, 11		
:6	66+80	5800	11.7.88	1299, 18		
7	67+80	*5800	1167, 83	1298.03		
8	68+80	5800	1164, 26	1298,06		
9	69+80	5800	11 3.40	1298,60		
10	70+80	5800	116), 86	1298, 55		
11	71+80	5800	116 1.79	1298, 70		
12	72+80	5800	1164, 38	1298, 08		
13	73+80	5800	157,62	1298, 42		
14	74+80	5800	1.45.86	1298, 86		
15	75+60	5800	1146.00	1299, 80		
16	76+20	5850	1151.33	1299, 43		
17	76+90	5850	1149,34	1299, 94		
18	77+60	5850	1146,98	1299, 48		
19	78+30	5830	1149,64	1299, 94		
20	79+00	5850	1146, 44	1299.34		
21	79+70	5850	1148,02	1299, 32		
22	80+40	5850	1148.83	1299.63

PIEZOMETER TUBE LOCATIONS						
PIEZ Tube No.	STATION	RANGE	BOTTOM ELEVATION	TOP TUBE ELEVATION		
1	61+30	5800	1237, 64	1302, 04		
2	63+30	5800	1228.42	1301.12		
3	66+30	5800	1225, 10	1301.90		
4	69+30	5800	1224,30	1301,10		
44	69+30	5805	1187.03	1300, 83		
5	72+30	5800	1220,84	1301.34		
6	75+15	5800	1225, 10	1303.00		
7	77+35	5850	1223, 35	1301.85		
8	79+35	5850	1219, 16	1301.76		
8A	80+00	5850	1121.85	1302,05		
88	79+90	5850	1121.85	1302, 25		
8C	79+80	5850	1120,90	1302, 15		
8D	79+80	5850	1181,75	1302, 30

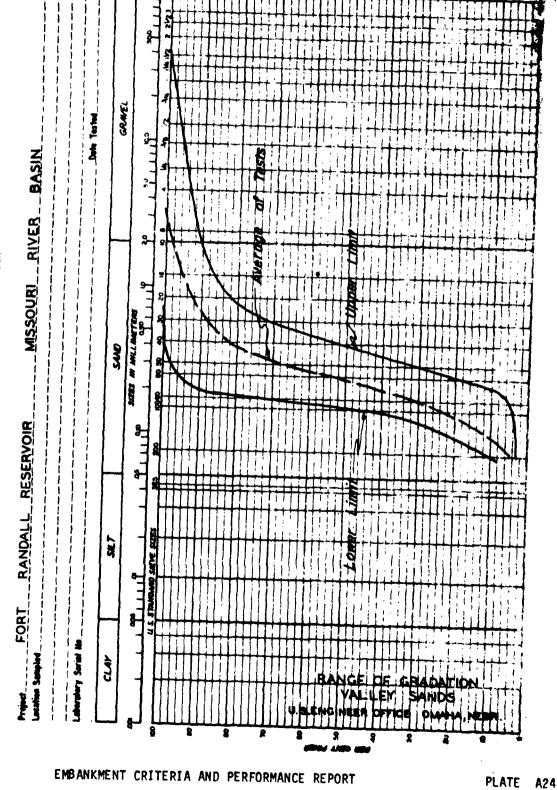
Dete Tosted. GRAVEL MISSOURI RIVER BASIN JALYSIS CURVES LLS ENGNEER LABORATORY LLS DIGHEST OFFICE - MISSOUR INVER ENVIRON SIZES IN MILLIMETERS 3 S Average of MECHANICAL 96 1 1 1 Preparation Supplies - FORT BANDALL RESERVOIR 21/12 Leberatory Serial No. 3

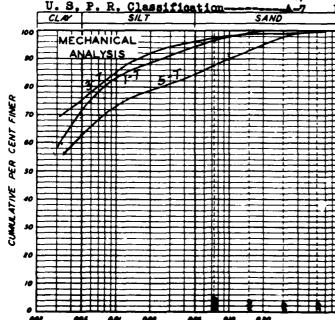
SHEARING STRENGTH
Maximum: c = .40 tan \$\phi = .42
Ultimate: c = .30 tan \$\phi = .22
Sample consolidated under vertical
load before application of strain.
Strain applied by motor drive.

Moisture, before test = 29.5% Voids, before test = 50.0% Specific Gravity = 2.80 Liquid Limit-- 90 Plastic Limit-32 Plasticity Index---~ 58 Flow Index---- 24 Shrinkage Limit ------- 17.7% Shrinkage Ratio ---- 1.870 Lineal Shrinkage---Field Moisture Equiv .--

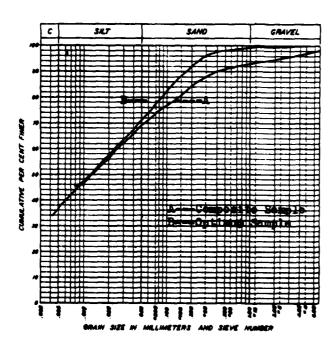
### GLACIAL TILL OPTIMUM MOISTURE TEST

Test No238	Specific Gravity
STANDARD PRO Sample compacted in 1.5 of a 5.5 th hammer dr Diameter of Cylinder 4 Source of Sample Compo	_inch layers by _25blows ropped _12inches _inches site of samples 1 to 10 ole C42. Elevation-
Project Fort Randal	l Damsite

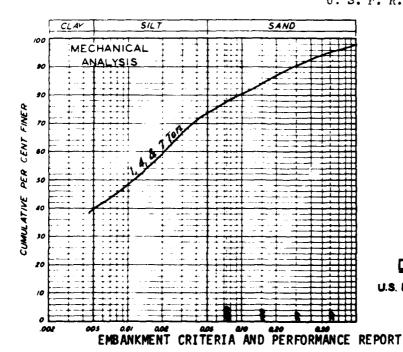
## RECOMPACTED GLACIAL TILL DIRECT SHEAR TEST

SHEARING STRENGTH  $c = 0.40 \tan \phi = 0.57$ Tests preconsolidated at vertical load. Strain applied by motor drive: Moisture, before test ----Voids, before test -----41.9 % Dry Density -----98 lbs/cu. ft. Specific Gravity -----Liquid Limit ----Plastic Limit ----26 Plasticity Index ----Shrinkage Limit -----Shrinkage Ratio -----Lineal Shrinkage -----11 % Volumetric Change from Liquid Limit-42 % U. S. P. R. Classification ----A-7

Project Fort and all Damsite
Stream Missouri River
Hole No. C 42
Location.
Ground Elev. 1434.9
Sample No. Composite of Samples
Depth. 0-25!
Remarks Samples remolded.

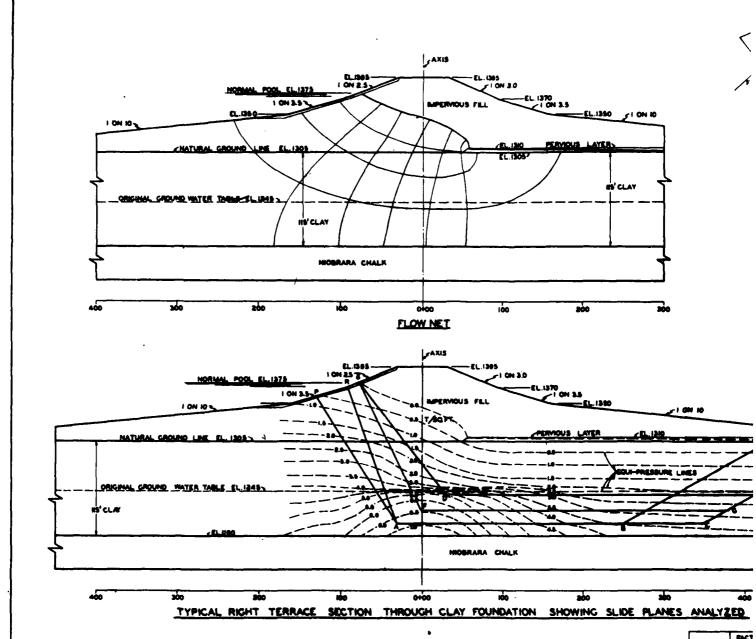
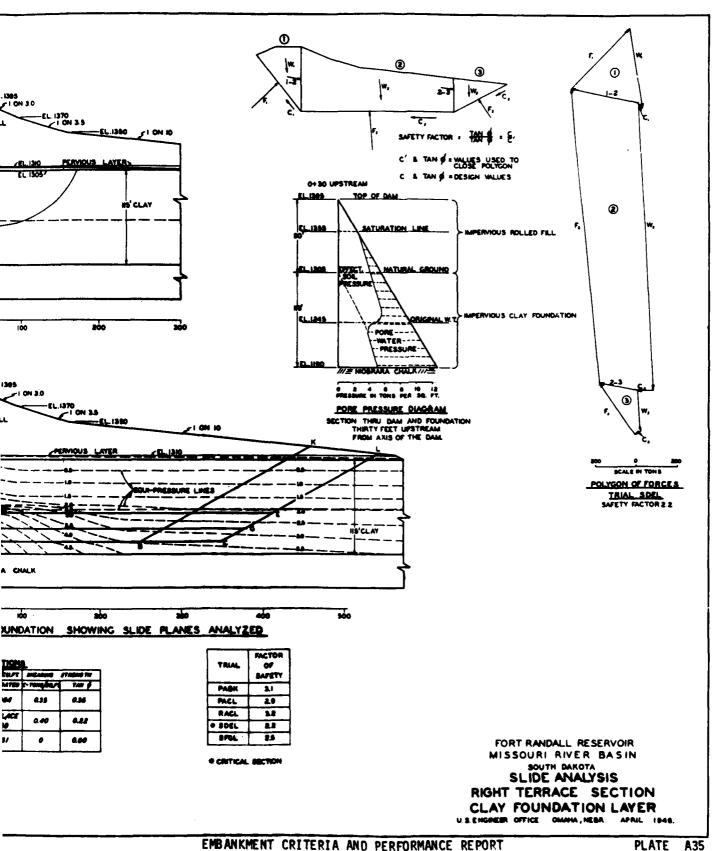
NOTES. EQUI- PRESSURE LINES ARE OBTAINED FROM FLOW NETS.

DESIGN ASSUMPTIONS				
AMPERMAL.	sanoviv — rangitu./T			
	AS PLACED	ANTHANTED	- nonghe/	740
AGLLED MAPERNIOUS PILL	262	.004	a)ş	0.36
CLAY POUNDATION	IN PLACE DS7	IN PLACE ISS	0.40	0.22
ARAN (PERMOUS)	.068	.06/	•	0.00

CRITICAL SECTI

the thick clay deposit on the right bank terrace. The analysis is graphically shown on Plate A-35. With impervious layers above and below the saturated clay, drainage would be greatly impeded and the pore pressure due to the fill load would be dissipated very slowly. For the stability analysis, very little consolidation of the clay foundation was assumed to occur during construction. The minimum factor of safety obtained was 2.2 which was believed to be adequate for the method of analysis used. A reanalysis in 1952 during construction of the project indicated a reduced factor of safety of 1.4, primarily due to the use of a higher ground water level and also to minor changes in the embankment section. The ground water level was raised from Elev. 1,245 to Elev. 1,275. The toe of the embankment was changed to a 1V on 3H slope instead of a feathered slope, and the pervious drain blanket did not extend as far upstream as in the original embankment section analyzed.

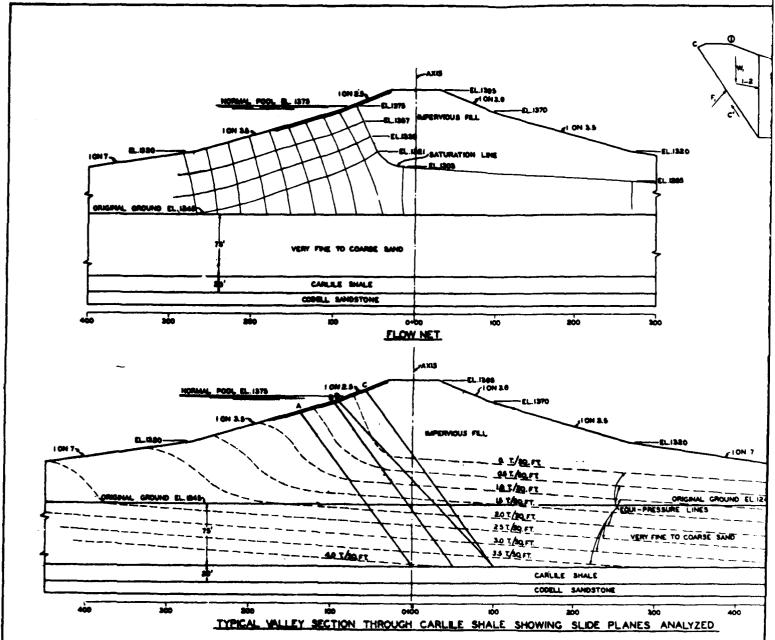
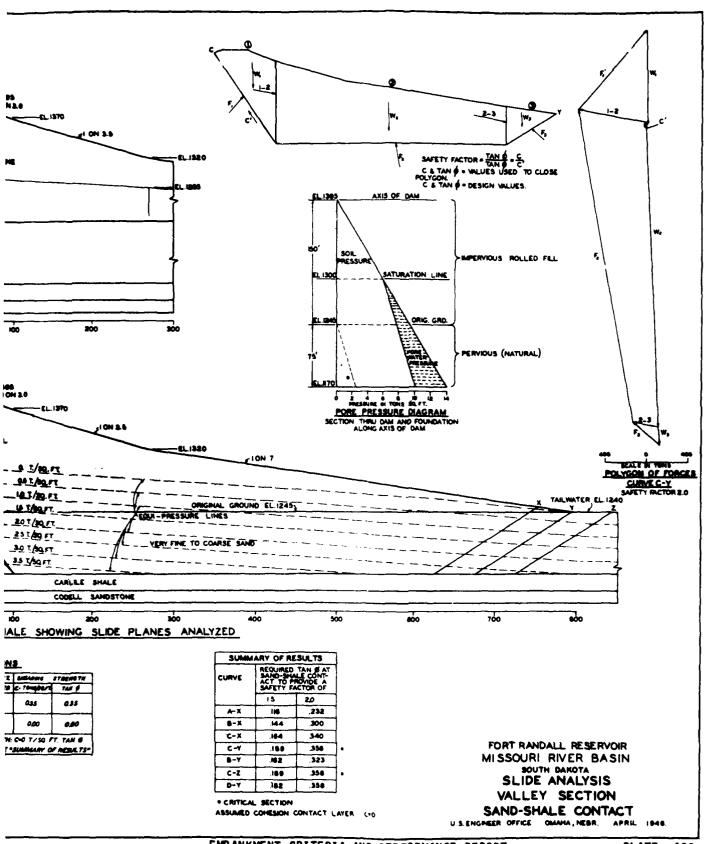
HOTES.
SOUT-PRESSURE LINES ARE OBTUNED FROM PLOW HETS.,

#### DESIGN ASSUMPTIONS

\* CRITICAL SECTION ASSUMED CONESID

10.2 Stability of Embankment Over Valley Alluvium. The embankment section overlying the valley alluvium was analyzed during the initial design stage by the "wedge" method, as graphically presented on Plate A-36. The section did not include the chalk berms as the extent of the berms were not known at that time. When the analysis was made, test results were not available on the strength of the shale foundation. The required shear strengths computed for safety factors of 1.5 and 2.0, assuming zero cohesion, were tan  $\emptyset = 0.189$  and tan  $\emptyset = 0.358$ , respectively. Consolidated direct shear tests later indicated a tan  $\emptyset = 0.3$  and cohesion = 0.1 tons per square foot for the shale. On this basis, a factor of safety of about 1.8 was assumed for the analysis. The safety factor is actually much higher due to the presence of the chalk berms.

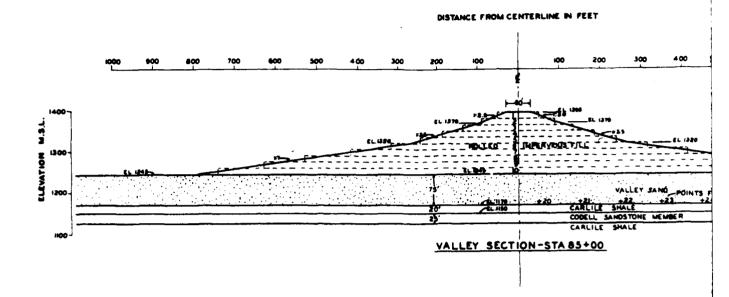
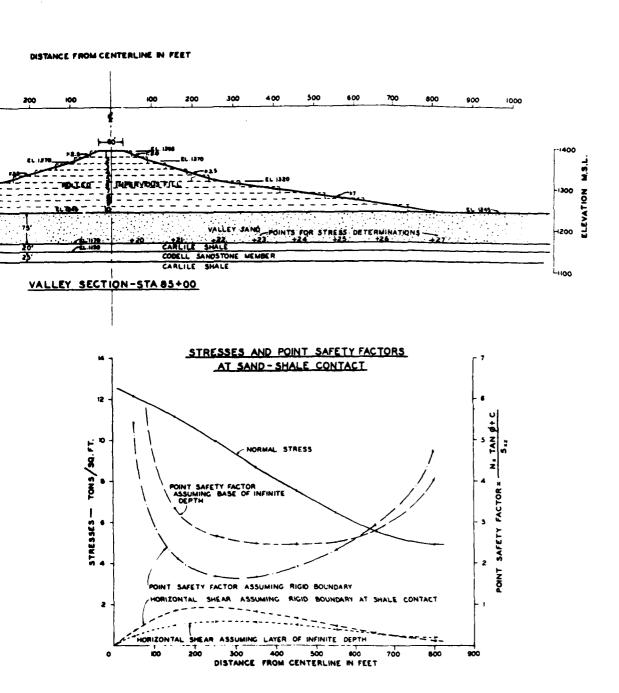
FORT RANDALL RESERVOIR
MISSOURI RIVER BASIN
SOUTH DAKOTA
STABILITY ANALYSIS
VALLEY SAND-SHALE CONTACT
ELASTIC THEORY METHOD
USERN WER OFFICE OMAHA NEBR APRIL 1940

# DESIGN ASSUMPTIONS

DENSITY	TONS/EU ET	SHEARING	STRENGTH
MATERIAL	AS PLACED	SATURATED	TONS/SF	TANS
ROLLED FILL	.062	.064	0.35	0.35
FOUNDATION SAND	IN PLACE 052	061	0	06
SAND-SHALE CONTACT	T		0.1	0.3

shale might act as a rigid boundary. It is believed that actual conditions are somewhere intermediate between these assumptions. Using the rigid boundary assumption, the minimum safety factor against horizontal sliding along the contact at any point was found to be 1.7. On the other hand, the infinite depth assumption gave a minimum point safety factor of 2.5.

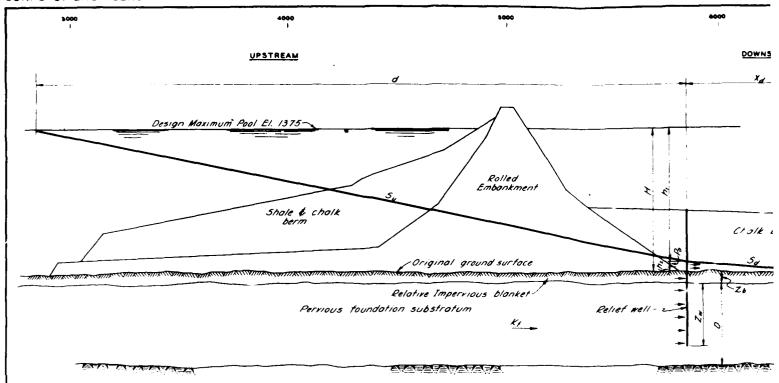
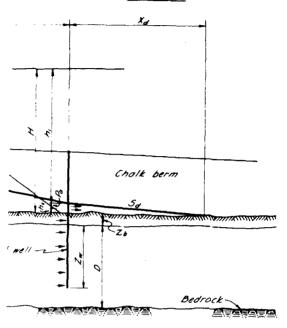
FORT RANDALL DAM-LAKE FRANCIS CASE EMBANKMENT RELIEF WELL STUDY TYPICAL WELL SPACING COMPUTATIONS

# TYPICAL SECTION ILLUSTRATING NOMENCLATURE

# TYPICAL COMPUTATION FOR FULLY PENETRATING WELL STA. 65+00 TO STA. 75+00

The computed value for \$6 th, corresponds to the assumed value in the second trial however the total computed patential. \$2 th, is greater than the allowable value, therefore the spacing of 100 ft is inadequate. The computed value for \$3 th, corresponds to the assumed value in the third trial and the latal computed patential \$3 th, is approximately equal to the allowable value, therefore the spacing of \$10 ft. is adequate.

# **NOMENCLATURE**

- Thickness of relatively impervious downstream blanket. ō
  - Thickness of pervious substratum.
  - Depth of proposed relief well.
- H Total head
- Mean potential over plane of wells.
- Surface potential at mid-point between partially penetrating wells
- hx . Head loss due to flow out of well screen into chalk berm.
- h, H-(Pa + hx) = Total headloss from source to line of wells
- d Effective resistance upstream of line of wells
- Effective resistance downstream of line of wells. 5
  - $5_u 5_d = Net potential gradient producing discharge$ from wells.
- a Well spocing.

- d = 3200 ft. All gradients are approximately
- 2
- and the standard by effective radius of well by pumping test.  $K_1 = 400$  ft as indicated by effective radius of well by pumping test.  $K_1 = 002$  cfs = Horizontal permeability of previous substratum. Ratio of horizontal permeability to rectical permeability of foundation material is in the order of 16 to 1.

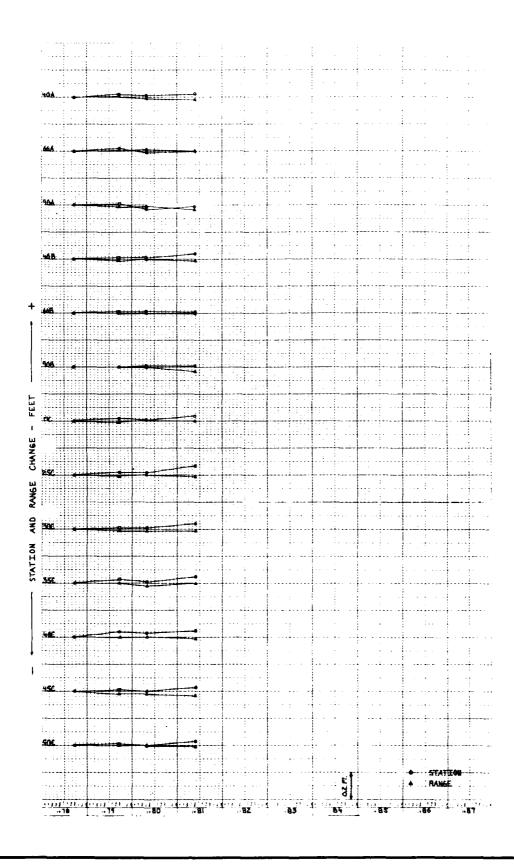
THIS DRADING HAS BEEN BEBUCED TO THREE-EIGHTHS THE ORIGINAL SCALE FOR LOCATION PLAN SEE PLATE 456 U. B. ARMY ENBINEER DISTRICT, OMAHA CORPE OF EMBINEERS OMAHA, NEBRASKA MISSOURY AXVER FORT RANDALL DAM CREST AND SLOPE MOVEMENT MARKERS HORIZONTAL MOVEMENT THE PLAN ACCOMPANIES SONTEAST NO. MOSPICATION No. EMBANKMENT CRITERIA AND PERFORMANCE REPORT PLATE AST

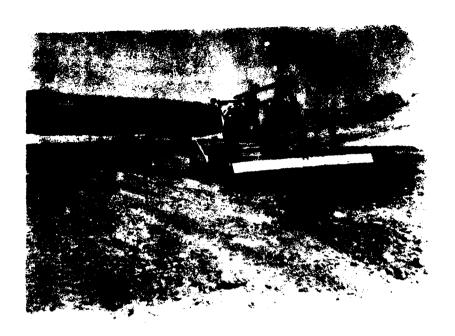
PHOTO NO. 2: Scarifying surface prior to placement of fill. Earthwork Stage II. 20 May '49

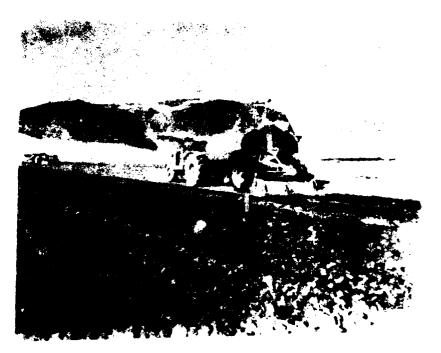
PHOTO NO. 4: Watering operation in embankment construction. Earthwork Stage II. 20 May '49

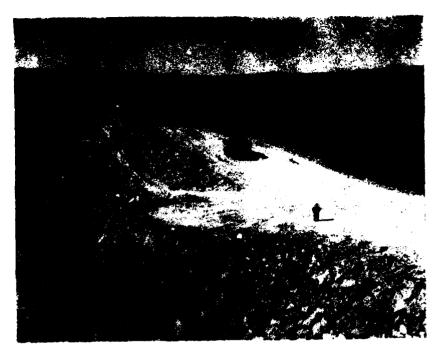
PHOTO NO. 10: Dumped chalk fill over the dredged chalk weir crest. Earthwork Stage III. 23 Jul '52

The diversion dam consisted of a lower, wide-based chalk blanket, a dredged chalk weir section, and an upper dumped chalk dike. Stage construction of the dam is indicated by the sections shown on Plate A-22. The chalk blanket was placed to Elev. 1230 approximately 10 feet below the river level, from 29 April 1952 through 22 May 1952. Construction of the dam was temporarily suspended until 7 July 1952 while the outlet works approach and discharge channel plugs were being removed. The diversion weir section was then constructed from 8 July 1952 through 20 July 1952 to Elev. 1244, about 2 feet above the headwater level, to complete the river diversion. By 29 July 1952, the diversion structure was completed by end dumping chalk directly onto the weir section to Elev. 1265. Photo No. 9 shows placement of dredged chalk for the construction of the diversion weir and Photo No. 10 shows end dumping operations in building the dike over the weir section.

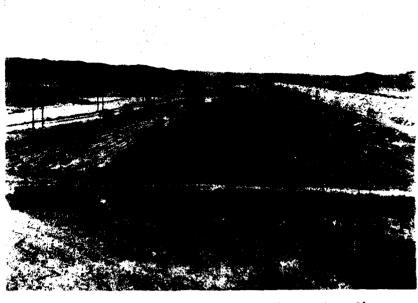
PHOTO NO. 22: View of embankment construction looking along dam axis towards the right abutment. Earthwork Stage V. 25 May '54

Plate No.	Photo No. and Description		
B-11	Photo No. 20 - Construction of upstream chalk berm, looking S.W. towards right abutment. 4 Aug 53.		
	Photo No. 21 - Aerial view of construction during Earthwork Stage V. 16 Nov 53.		
B-12	Photo No. 22 - View of embankment construction looking along dam axis towards the right abutment. Earthwork Stage V. 25 May 54.		
	Photo No. 23 - Fill placement between west spillway abutment and previously completed embankment. Top of fill is approximately El. 1,360. 25 Jun 54.		
B-13	Photo No. 24 - Aerial veiw of completed embankment, looking from right abutment. 30 Jun 55.  Photo No. 25 - Aerial view of project, looking S.W. 29 Mar 55.

- 4.6 Earthwork Stage V (July 1953 - November 1955). Earthwork Stage V was the final embankment construction stage. The embankment over the right bank and closure section was raised to its design crest elevation of 1,395. The left bank portion of the embankment had previously been constructed to Elev. 1,395 under Earthwork Stage III. The entire length of the embankment crest was overbuilt to heights up to 3.5 feet, as indicated on Plate Al9, to compensate for post construction settlement. The embankment at both abutments of the spillway structure was constructed to the final crest elevation of 1,395. The left and right bank embankment toe drains were installed and 14 of the 36 previously installed relief wells were raised in conjunction with raising of the chalk berm in the downstream closure area. Excavation of the spillway discharge channel was also completed under this earthwork contract. Approximately 4,330,000 cubic yards of impervious fill and 27,000 cubic yards of pervious drain fill were placed in the compacted embankment. In addition, about 4,560,000 cubic yards of chalk and shale were excavated from the spillway area and placed in the upstream and downstream berms of the embankment. Photos No. 21 through No. 25 were taken during Earthwork Stage V.
